## **CDTA COMMITTEE AGENDA**

Subject: Facility Condition Analysis Report (FCAR) Executive Summary

# **Facilities Department** **Facilities Condition Analysis Report**

# Updated Facility Condition Analysis Report & Comprehensive Master Plan

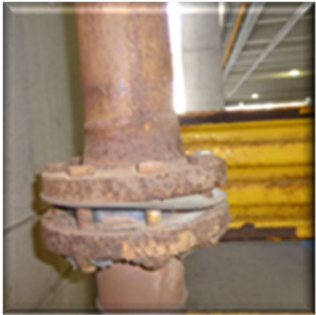
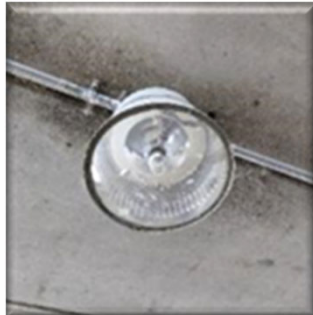
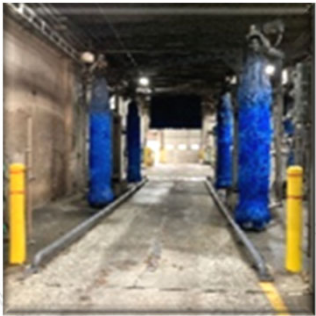
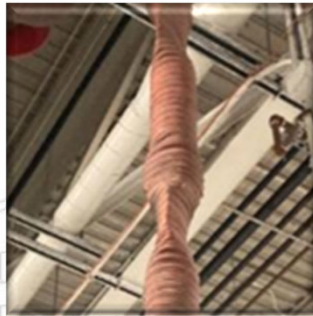
## Examples of Completed/In Progress Work:

- Bus Wash replacement in Troy
- Switch gear upgrades in Albany
- Lift replacement/Rebuild in Albany & Schenectady
- Emergency lighting replacement/additions
- HVAC upgrades at 85 & Schenectady
- Vehicle exhaust repair/replace
- Gas line replacement at RRS
- Lighting repair/replacement at RRS
