## **CDTA COMMITTEE AGENDA**

Subject: Facility Condition Analysis Report (FCAR) Executive Summary

# **Facilities Department** **Facilities Condition Analysis Report**

# Updated Facility Condition Analysis Report & Comprehensive Master Plan

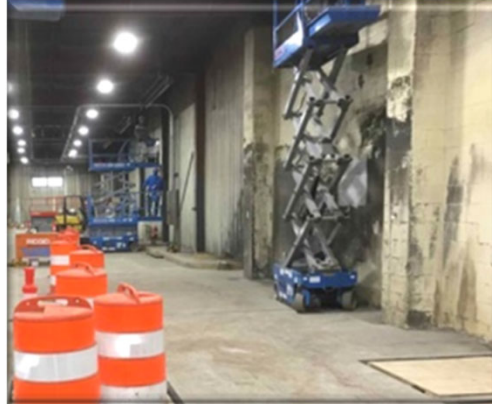
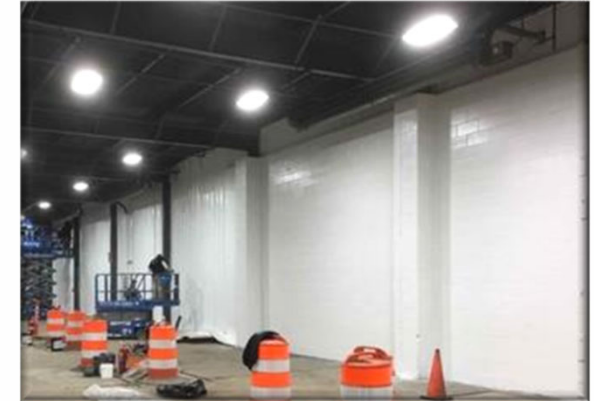
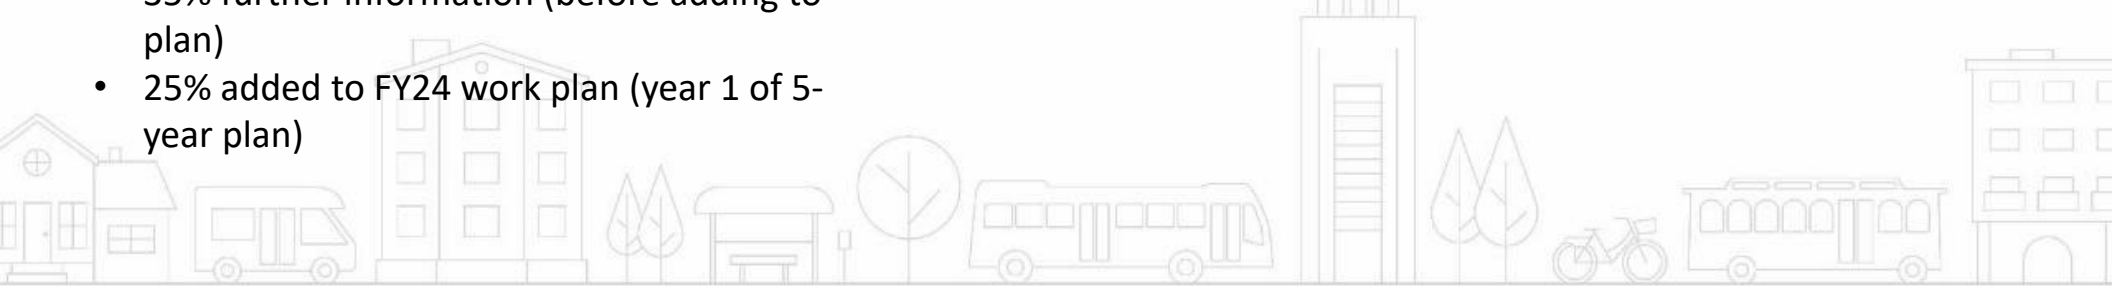
- 57 Total High Urgency Deficiencies
- 4 Categories
  - Open (added to annual workplan)
  - Open (further information needed)
  - In Progress
  - Completed
- 50% completed or in progress
- 35% further information (before adding to plan)
- 25% added to FY24 work plan (year 1 of 5-year plan)

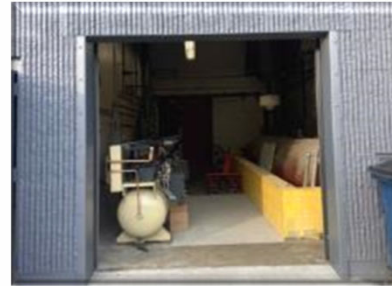
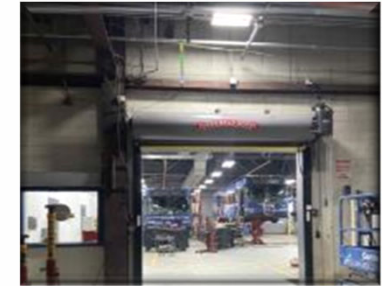
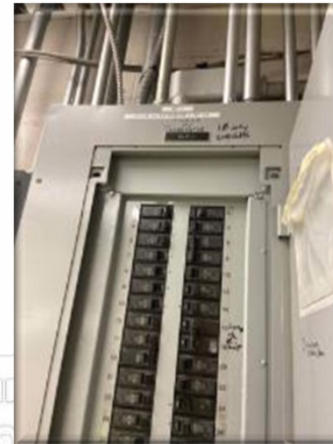
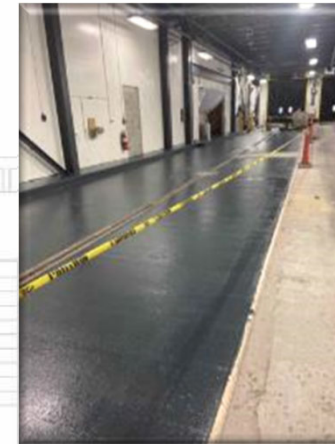
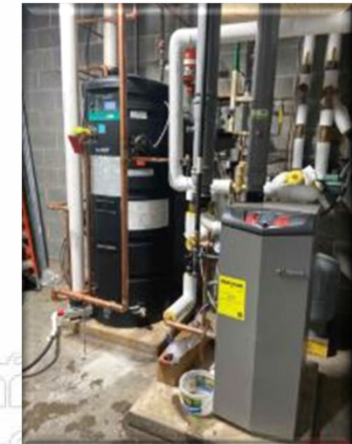
- 278 Medium Urgency Deficiencies (years 1-5)
- 259 Low Urgency Deficiencies (Years 5-10)
- 15% already completed through normal routine maintenance
- All to be reviewed to determine CDTA priority
- Priority work to be added to years 2-5 of 5-year plan
- Many funded through operating budget
- Some may be combined for capital expense/budget
